SUSQUEHANNA RIVER BASIN
BLAIR GAP RUN, BLAIR COUNTY

BLAIR GAP DAM

NDI I.D. NO: 521

PHASE I INSPECTION REPORT
NATIONAL DAM INSPECTION PROGRAM

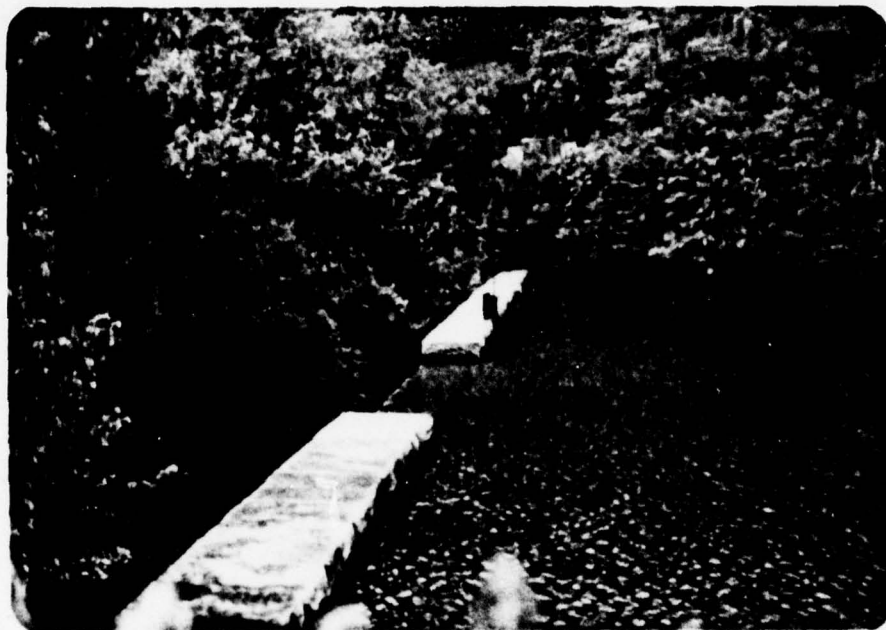
Upstream Face

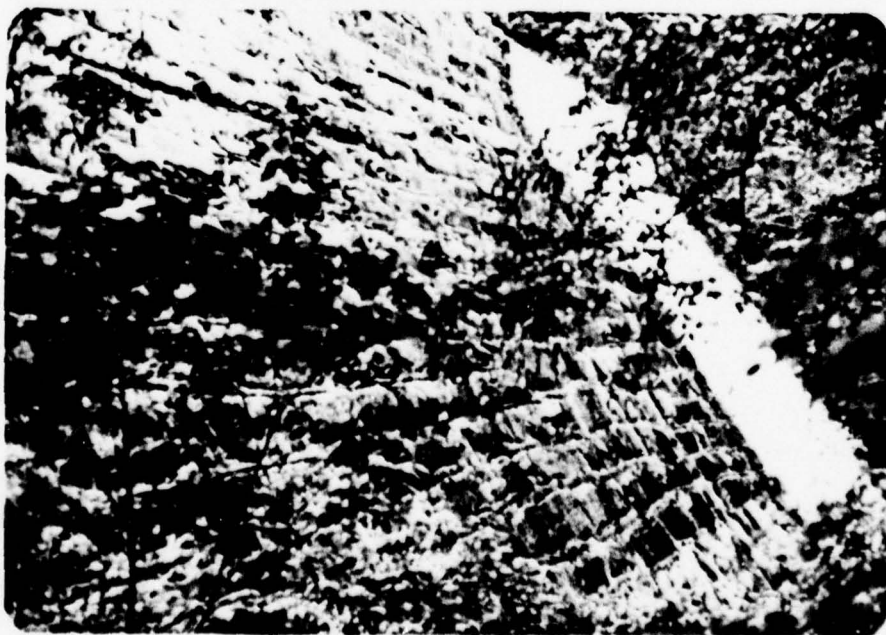
Downstream Face

1. Portions of the downstream face of the dam were found to be wet. Several seeps were located on the right side of the spillway. The discharge from these seeps was estimated to be one to two gallons per minute.
2. A concentrated seepage was found at the toe of the dam on the left side of the spillway. The discharge was estimated to be in the range of 5 to 10 gallons per minute. The seepage surface was covered with "yellow-boy" precipitate.

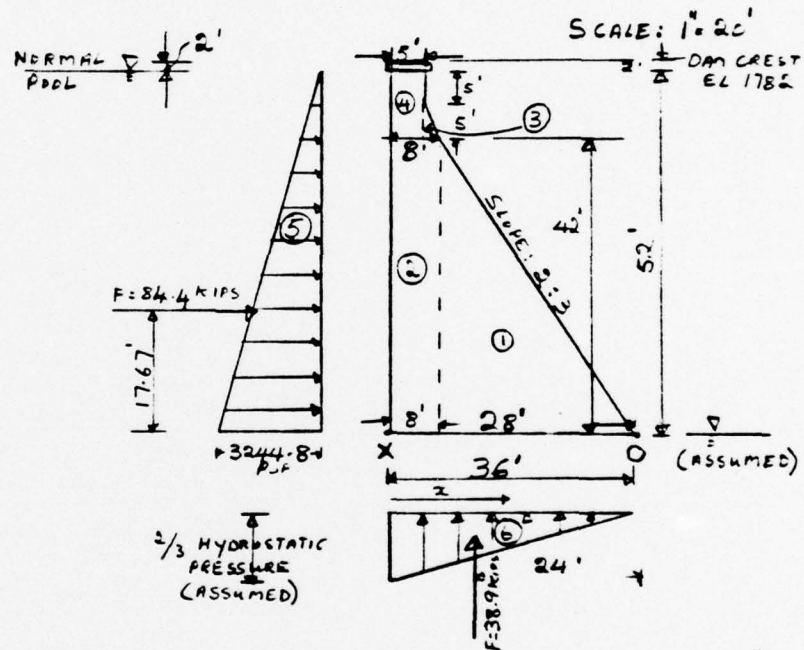
STABILITY ANALYSIS — NORMAL POOL

PRESSURE AT UPSTREAM END (FULL HYDROSTATIC PRESSURE)
 $= \gamma h = 62.4 \text{ LBS/FT}^3 \times 52' = 3244.8 \text{ PSF}$
 TOTAL FORCE $= \frac{1}{2} (3244.8 \times 52) = 84.4 \text{ KIPS/FT}$
 $F = 84.4 \text{ KIPS FOR A ONE FOOT SECTION OF DAM}$
